FMO now offers Motor Shaft Grounding, a maintenance program that prevents bearing failure and significantly extends motor life.

# The Blackstone Case Study

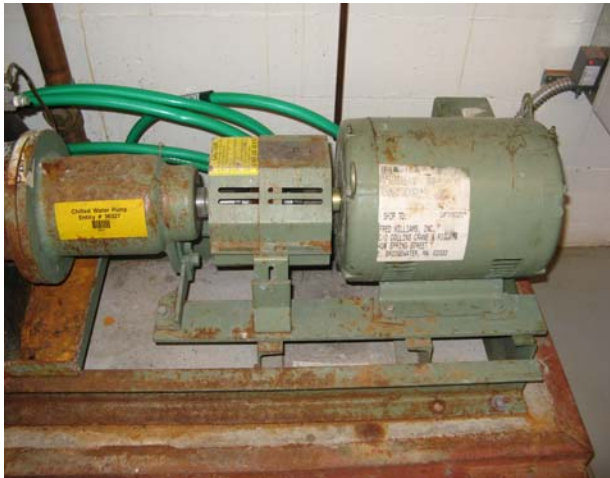
FMO monitored and recorded the voltage on the motor shaft of the chilled water pump in Blackstone South (illustration #3) using an AEGIS probe and oscilloscope. The probe, which has a high density conductive micro-fiber tip, was placed directly on the rotating shaft with the motor running (illustration #4).

### Illustration #3: Motor # 1, Blackstone South, Chilled Water Pump P-1

Baldor Cat # EM3311T  
Spec # 37F6144663  
7.5 HP  
230/460 Volts  
20/10 Amps  
1760 RPM  
213T Frame  
OBSB enclosure  
S # F0507221640  
Pump P-2 is similar with serial # F0507221505

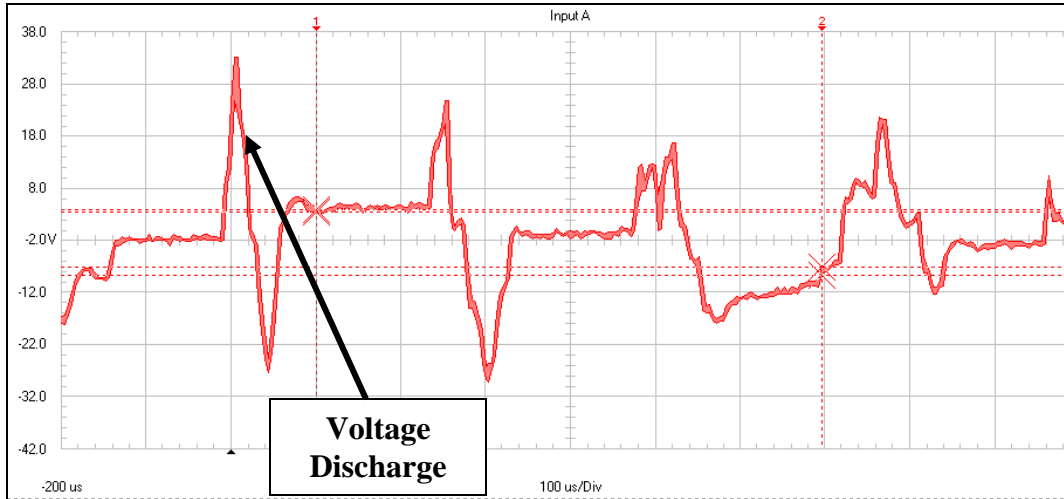
The graph below illustrates a steady discharge of harmful shaft voltages. As you'll notice later in Step 4, the absence of these voltages would result in a flat-line reading.

### Illustration #5: Test results from Motor # 1 without a Shaft Grounding Ring.
